Gerard v. Omega Flex

March 20, 2016

Executive Summary

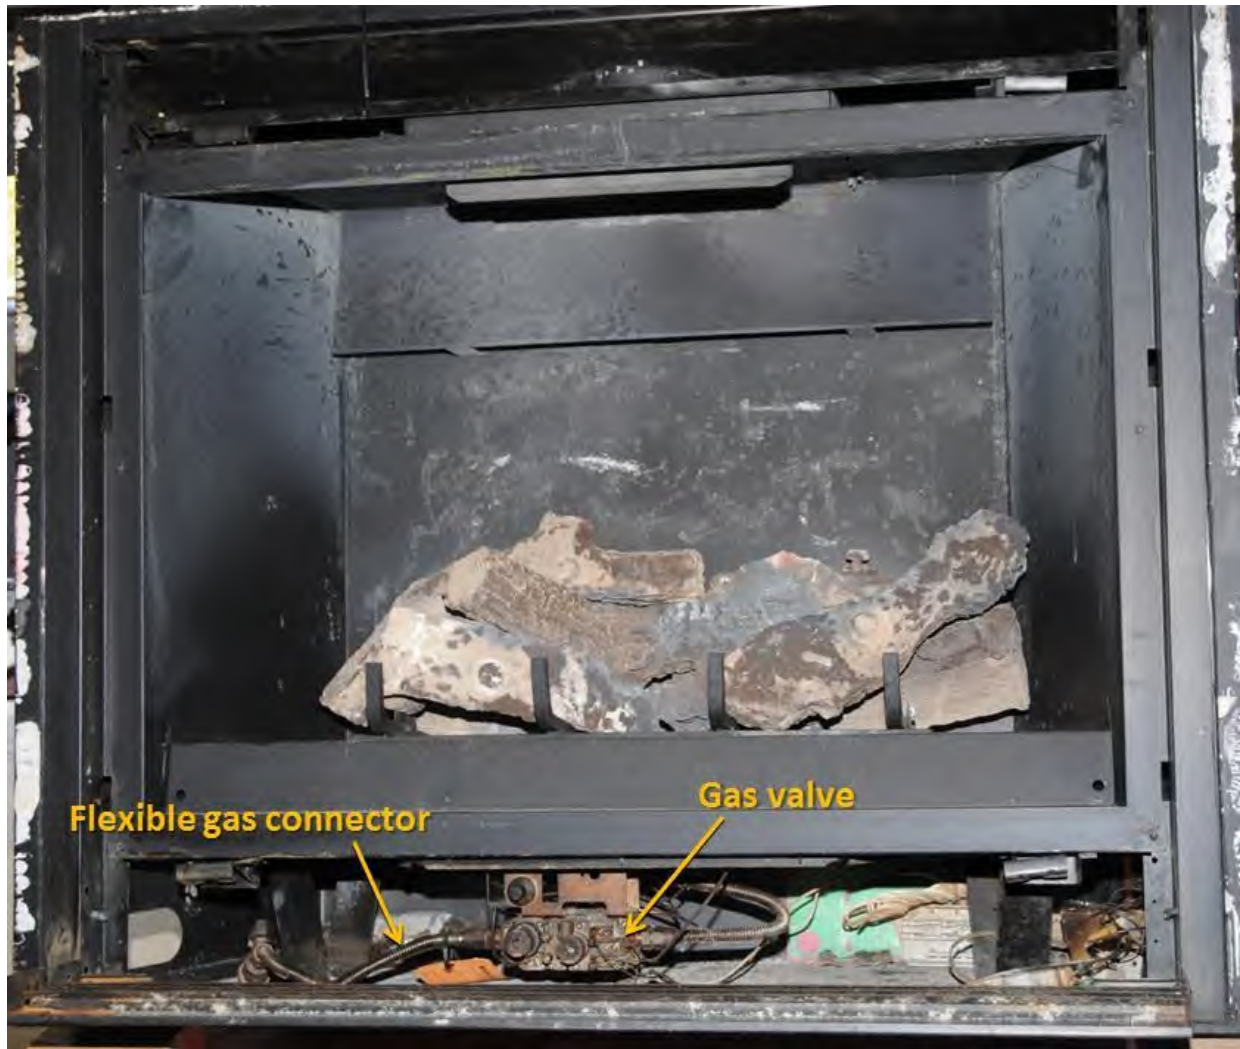
A layout of the first floor living room with the fireplace and a schematic diagram of the utilities is shown in Figure 3. The home was supplied with natural gas at the northeast corner. Black iron pipe was used to connect the natural gas supply to a water heater and a furnace in the basement. A section of ½" nominal TracPipe CSST connected to a tee in the black iron pipe supply piping and ran along the basement ceiling to the bottom of the fireplace in the first floor living room. The TracPipe CSST connected to a flexible gas connector, which was connected to the gas valve in a compartment underneath the fireplace, as shown in Figure 4.

Figure 4. Photograph of the fireplace from the living room of the Gerard home.

As shown above in Figure 4, the fireplace comprised two compartments, a larger main compartment and a smaller compartment underneath with a flexible gas connector and the gas valve. There were two holes in the flexible gas connector that ran from the TracPipe CSST to the gas valve in the bottom compartment of the fireplace (see Figure 20). Both holes showed molten and resolidified metal around the edges (see Figure 21), indicating that they were caused by electrical arcing. Both holes were approximately elliptical, one had dimensions of approximately 1 mm x 4 mm, while the other had dimensions of approximately 1 mm x 3 mm.

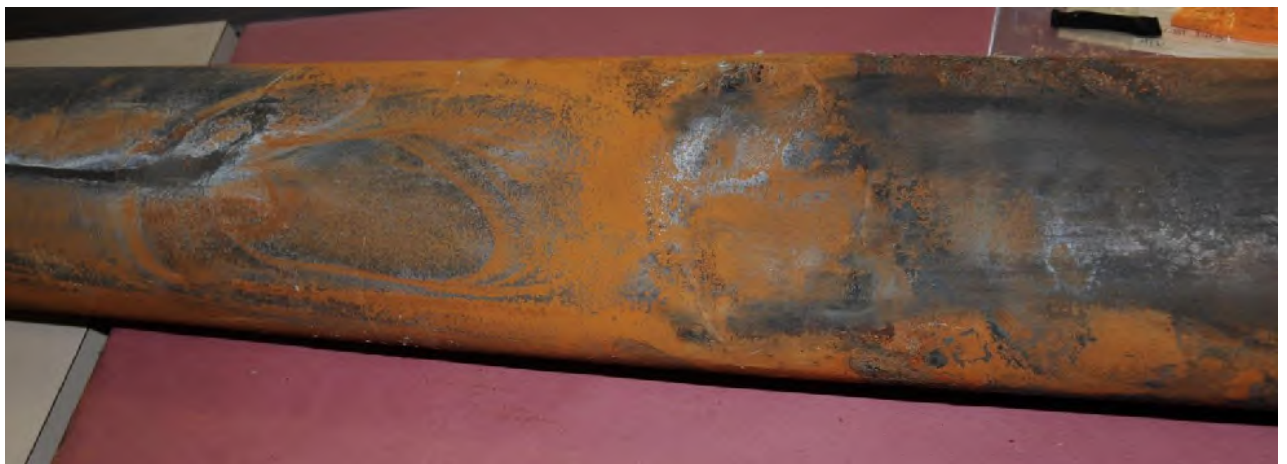
The HVAC duct that was retained ran along the basement ceiling in the Gerard home from the north side (near the furnace) toward the south side, approximately parallel to the TracPipe CSST line to the fireplace. The duct comprised two sections, shown in Figure 11 and Figure 12.

Figure 12. Photograph of the north section of the HVAC duct.

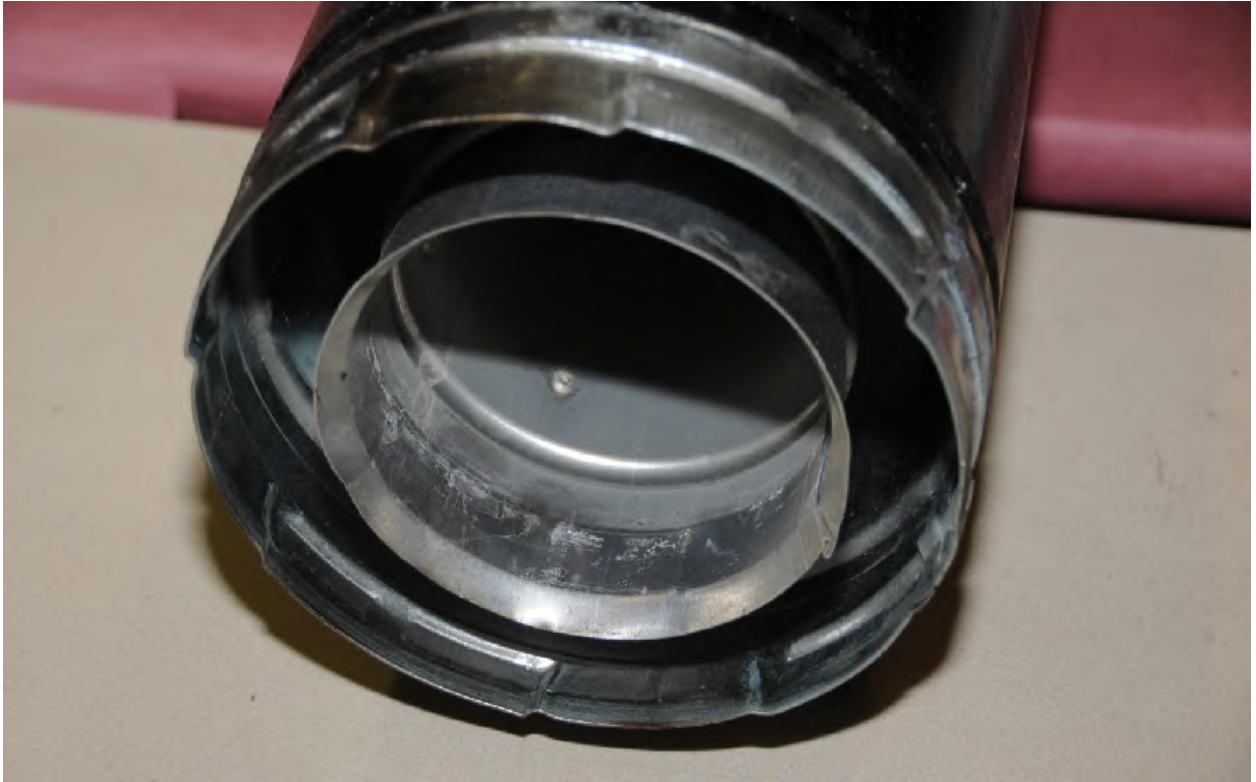
The flue pipe for the fireplace comprised multiple sections of double-walled vent piping (see Figure 14). It terminated at the top with a chimney cap (see Figure 15). There were multiple locations on the chimney cap where the metal had melted and resolidified (see Figure 16 and Figure 17). This damage indicates that lightning directly struck the flue pipe chimney cap.

Figure 14. Photograph of the double-walled fireplace flue piping.

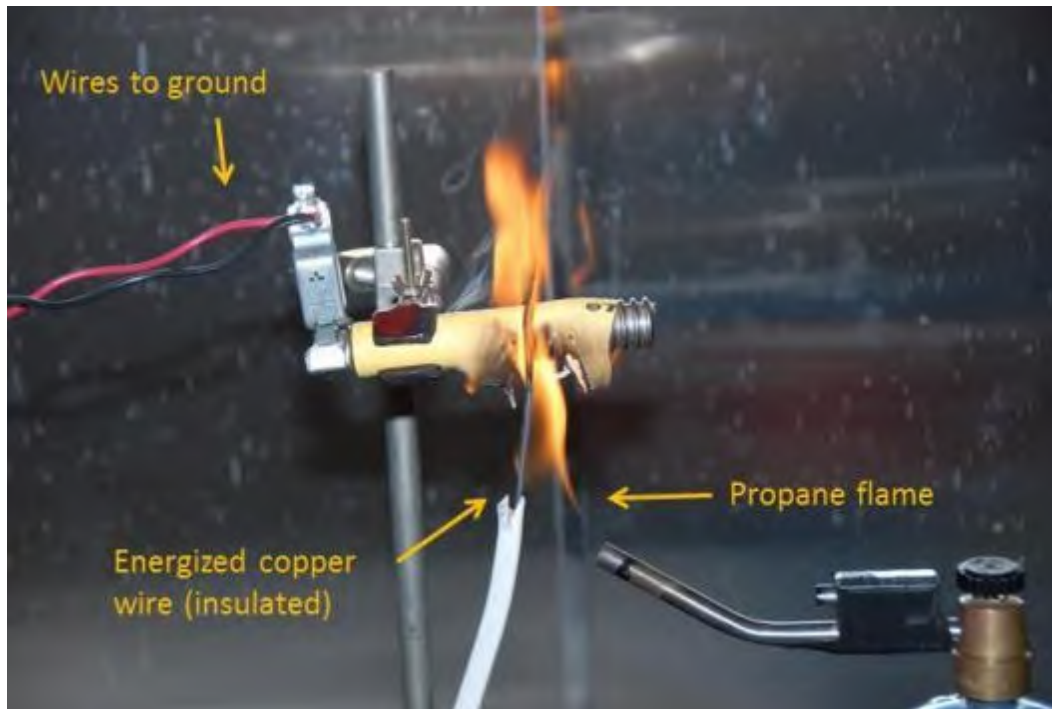
A 14 AWG branch circuit cable (type NM-B) was connected in series to a 15 amp rated circuit breaker which was supplied by a 120 VAC electrical outlet protected by a 20 amp breaker. The live (or hot) conductor was separated from the neutral and ground conductors and placed near a length of TracPipe that was connected to a grounded water pipe using a stainless steel hose clamp. The insulating jacket on both the TracPipe and the live conductor was kept intact. A propane diffusion flame was then applied under the TracPipe and live conductor. A photograph of a sample test is shown in Figure 1.

Figure 1. Photograph of the testing of TracPipe in proximity with energized branch circuit wiring in the presence of a flame.

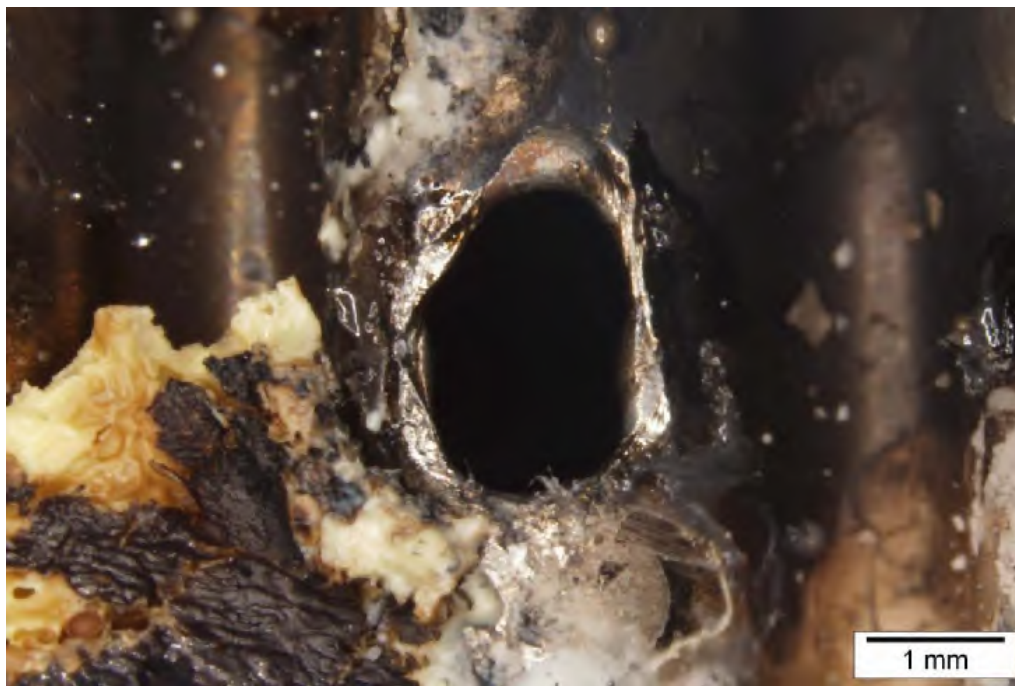
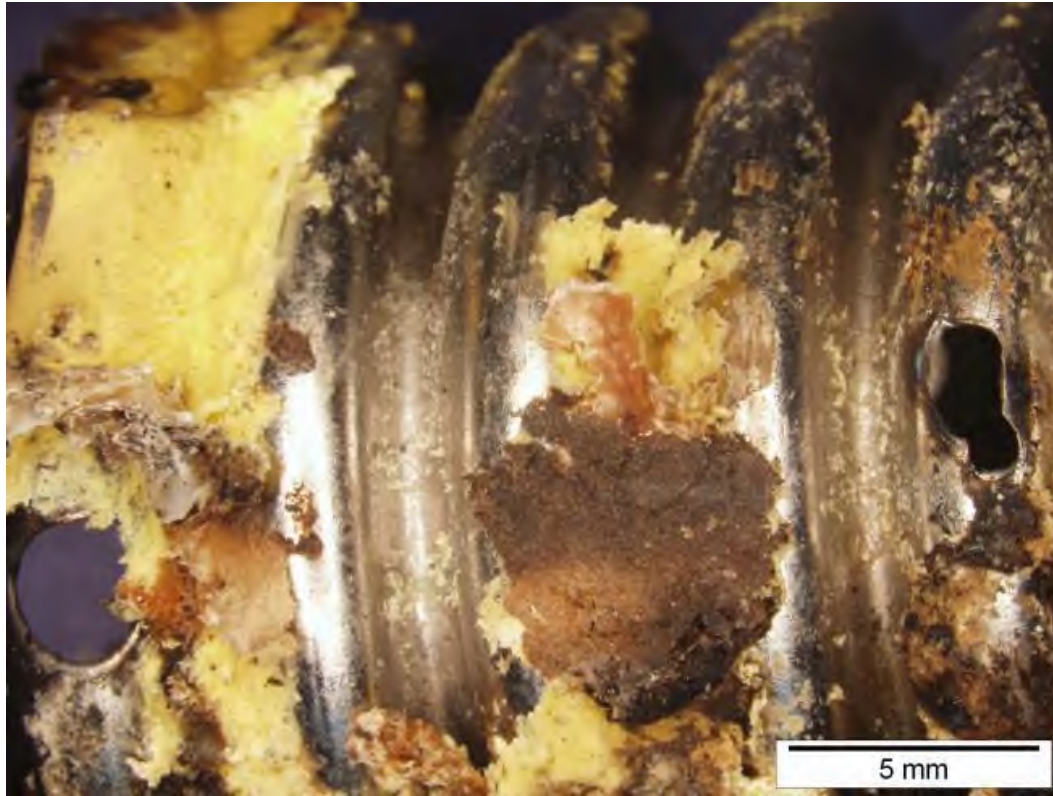
Even with the neutral and ground wires running along the hot (energized) wire, the hot wire arced to the TracPipe rather than to the neutral or to the ground, resulting in the formation of holes in the TracPipe (see Figure 4 and Figure 5). The reason arcing occurred to the TracPipe is because the fire consumed the outer portions of electrical insulation before it consumed the insulation between the individual conductors. This is likely due to the protection of the insulation material between conductors from the flame by the conductors themselves.

Figure 4. Optical microscope image of an example hole formed in TracPipe by a a three-conductor branch circuit wire.

Figure 5. Optical microscope image of two example holes formed in TracPipe by a three-conductor branch circuit wire.

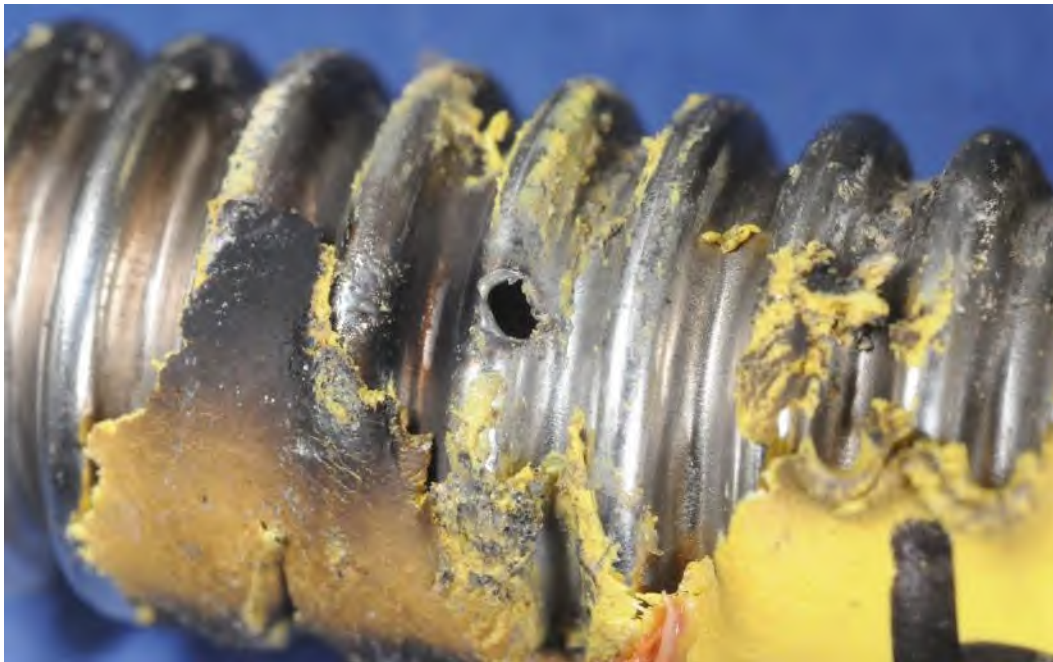
This test procedure was repeated with the resistor set to different resistances. By selecting different values of the resistance, the current that flowed through the arc could be controlled such that the circuit breaker tripped with either the magnetic or thermal mechanism. As expected, the hole size varied when the resistance (and thus the total charge transfer) was altered. Larger holes were observed with resistance values that caused the circuit breaker to trip with the slower thermal mechanism. Examples of holes from this testing are shown in Figure 8 and Figure 9 and Figure 10. These holes are irregular in shape and cross one or more corrugations of the TracPipe, exhibiting peninsulas or fingers at the edge of the hole.

Figure 8: Photograph of a hole (2 by 2 mm) in TracPipe created using a resistance of 0.15 Ω .

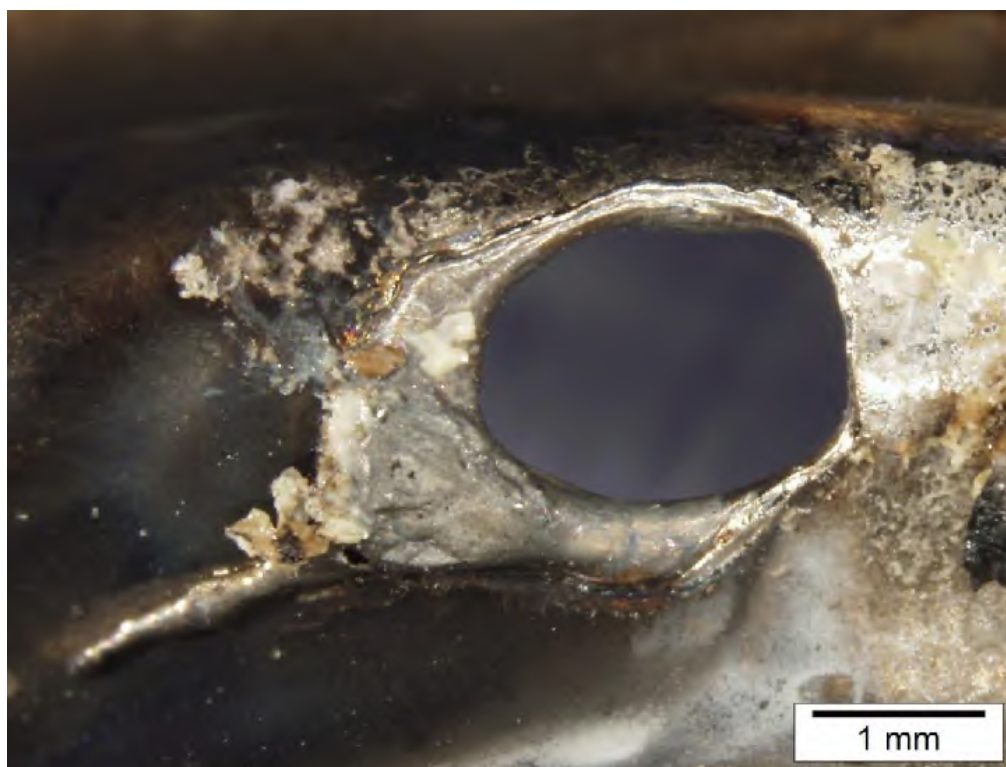
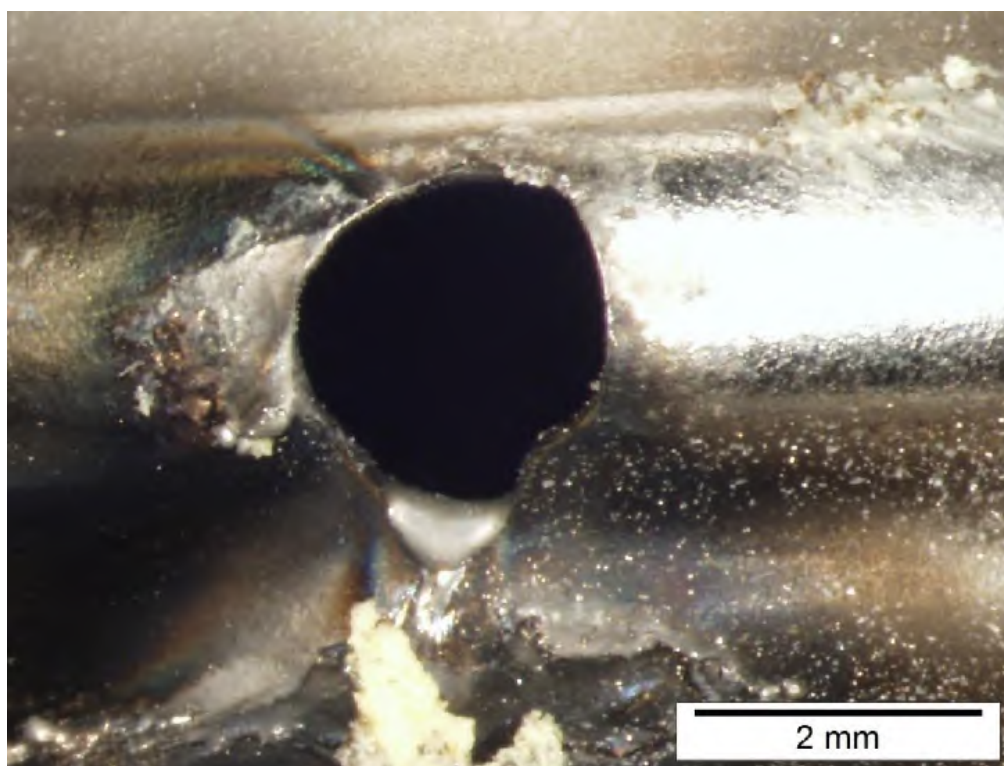
Testing with branch circuit wiring has also allowed Exponent to examine the morphological characteristics of such holes. Several examples are shown in Figure 11 through Figure 13. The character of the hole is similar to holes in TracPipe that were allegedly caused by an electrical arc due to lightning. This similarity makes it impossible to identify the source of electrical energy that caused the hole (lightning or household electricity) from an examination of the hole alone.

Figure 11. Image of a hole formed in TracPipe by household electricity in a flame.

Figure 12. Image of a hole formed in TracPipe by household electricity in a flame.

Figure 13. Image of a hole formed in TracPipe by household electricity in a flame.
